CASE STUDY

DUBBO FLOOD

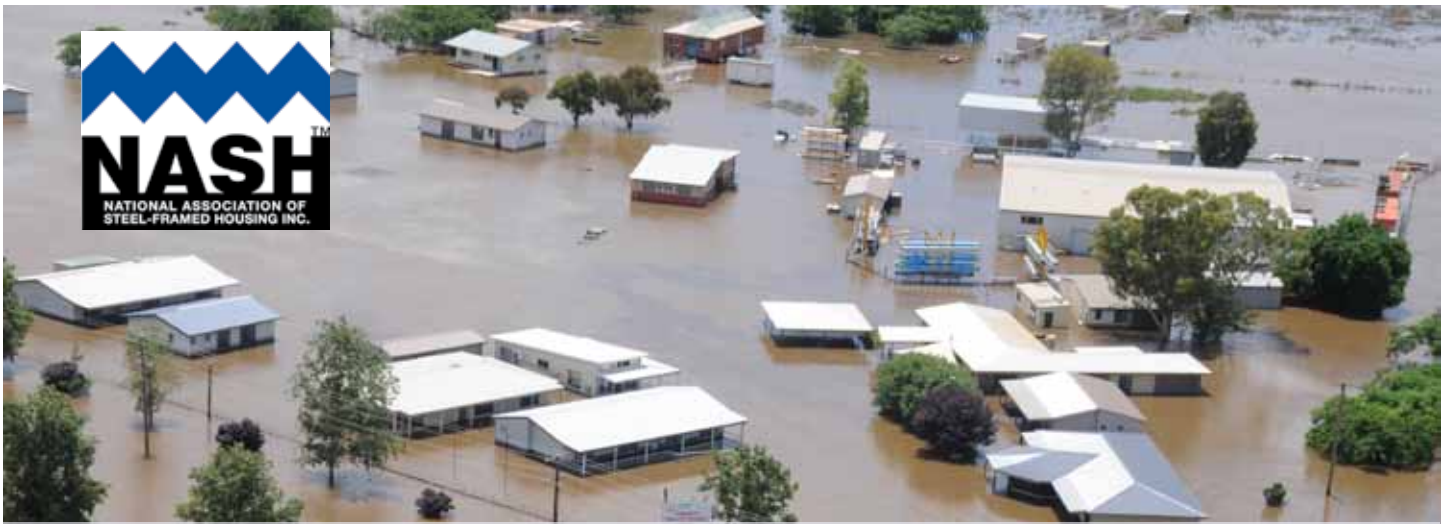
The transportable buildings were immersed in flood waters for 5 days from 500mm to 1 metre deep above floor level. The continuous floor beams/bearers prevented the buildings from moving or falling off piers/stands from the force of the flood waters.
