ASSESSING THE BUSHFIRE PERFORMANCE OF LOW-RISE STEEL STRUCTURES USING FULL SCALE BUSHFIRE FLAME FRONT SIMULATION

KB Watson¹, JE Leonard², I Bennetts³, MH Kelly⁴, L Macindoe⁵, and TG Clayton⁶

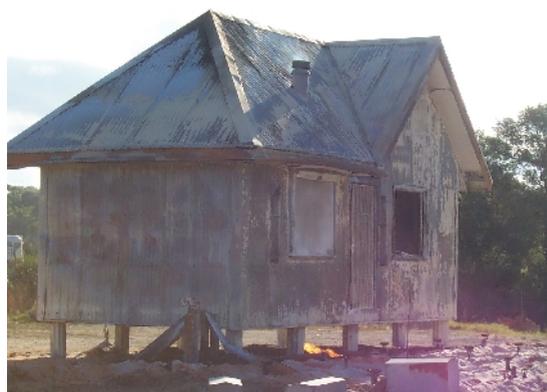
Testing took place on 16 April 2010. The test was a success with the simulator performing exceptionally well, providing a very realistic flame front simulation closely matching the target exposure profile. In effect the test was more severe than intended with the pre-radiation peaking 10 kW/m^2 above the profile and the flame immersion phase lasting 40 s longer than scheduled. This is reasonable given the first time nature of the test, scheduling preventing a full calibration of the burners and the unexpected extent of the flame immersion which almost enveloped the whole building including flame contact on the back wall. The building after the test is shown in Fig. 5.

- The floor system was still serviceable after the test. The bottom of the insulation was blackened.
- The wall system lost its insulation during the test and the steel studs suffered localised buckling due to thermal stresses.

- The roof system was still serviceable after the test. Most of the damage occurred at the eaves. The top of the ceiling insulation was blackened but otherwise unaffected. The roof insulation blanket was intact except near the eaves.

- The front timber solid core door was noted to be well alight before the flame immersion phase. Large gaps around the perimeter of the door were evident after the test. Timber solid core doors are only specified for BAL 40 and below in AS 3959-2009 and not BAL FZ flame zone situations.

Fig. 5 The building after the test

- Improved design of the wall system - additional protection/insulation is needed on the outside of the wall frame and around the eaves; use of rock wool rather than fibreglass to improve the heat resistance of the insulation
- Improved window and door systems required, including shutters capable of protecting low-specification products. Solution are needed for sealing gaps around openings to resist both smoke and heat.

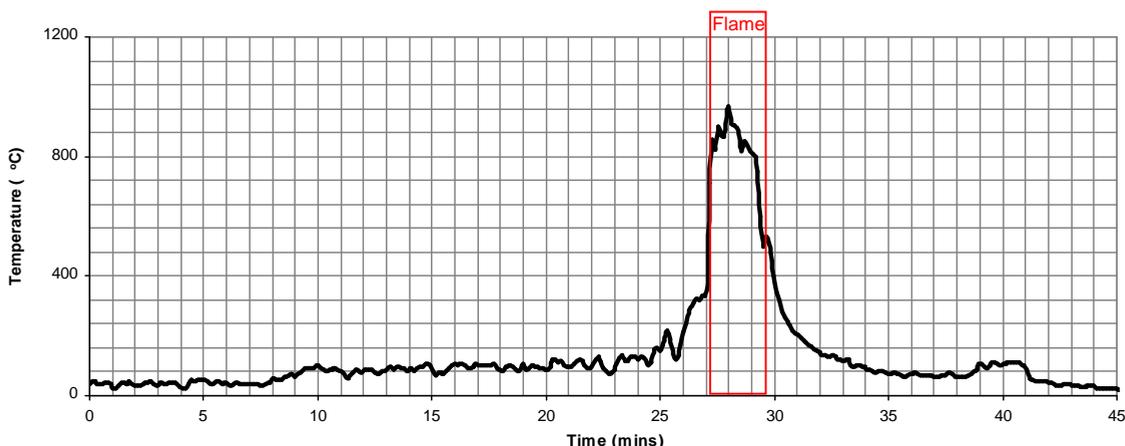
- The air temperatures on the outside of the building reached a peak of 1100°C . A plot of the average air temperature across the front wall of the building is shown in Fig. 6.

Fig. 6 Average air temperature across the front wall of the building

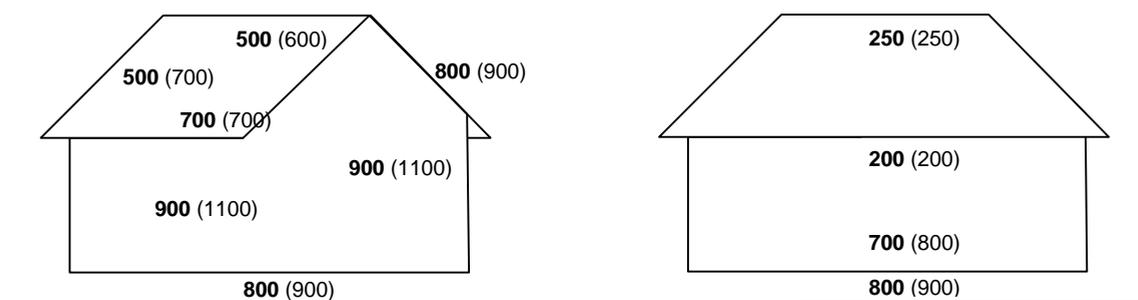
- The variation in the air temperature on the outside of the building is shown in Fig. 7.
- The stumps were protected (see Fig 2) from the heat. The data indicate they would have been exposed to excessive temperatures without this protection.

Fig. 7 Typical air temperatures on the outside of the building during flame exposure

(RHS: Front; LHS: Back; Peak values shown in brackets)
