CASE STUDY

DUBBO FLOOD

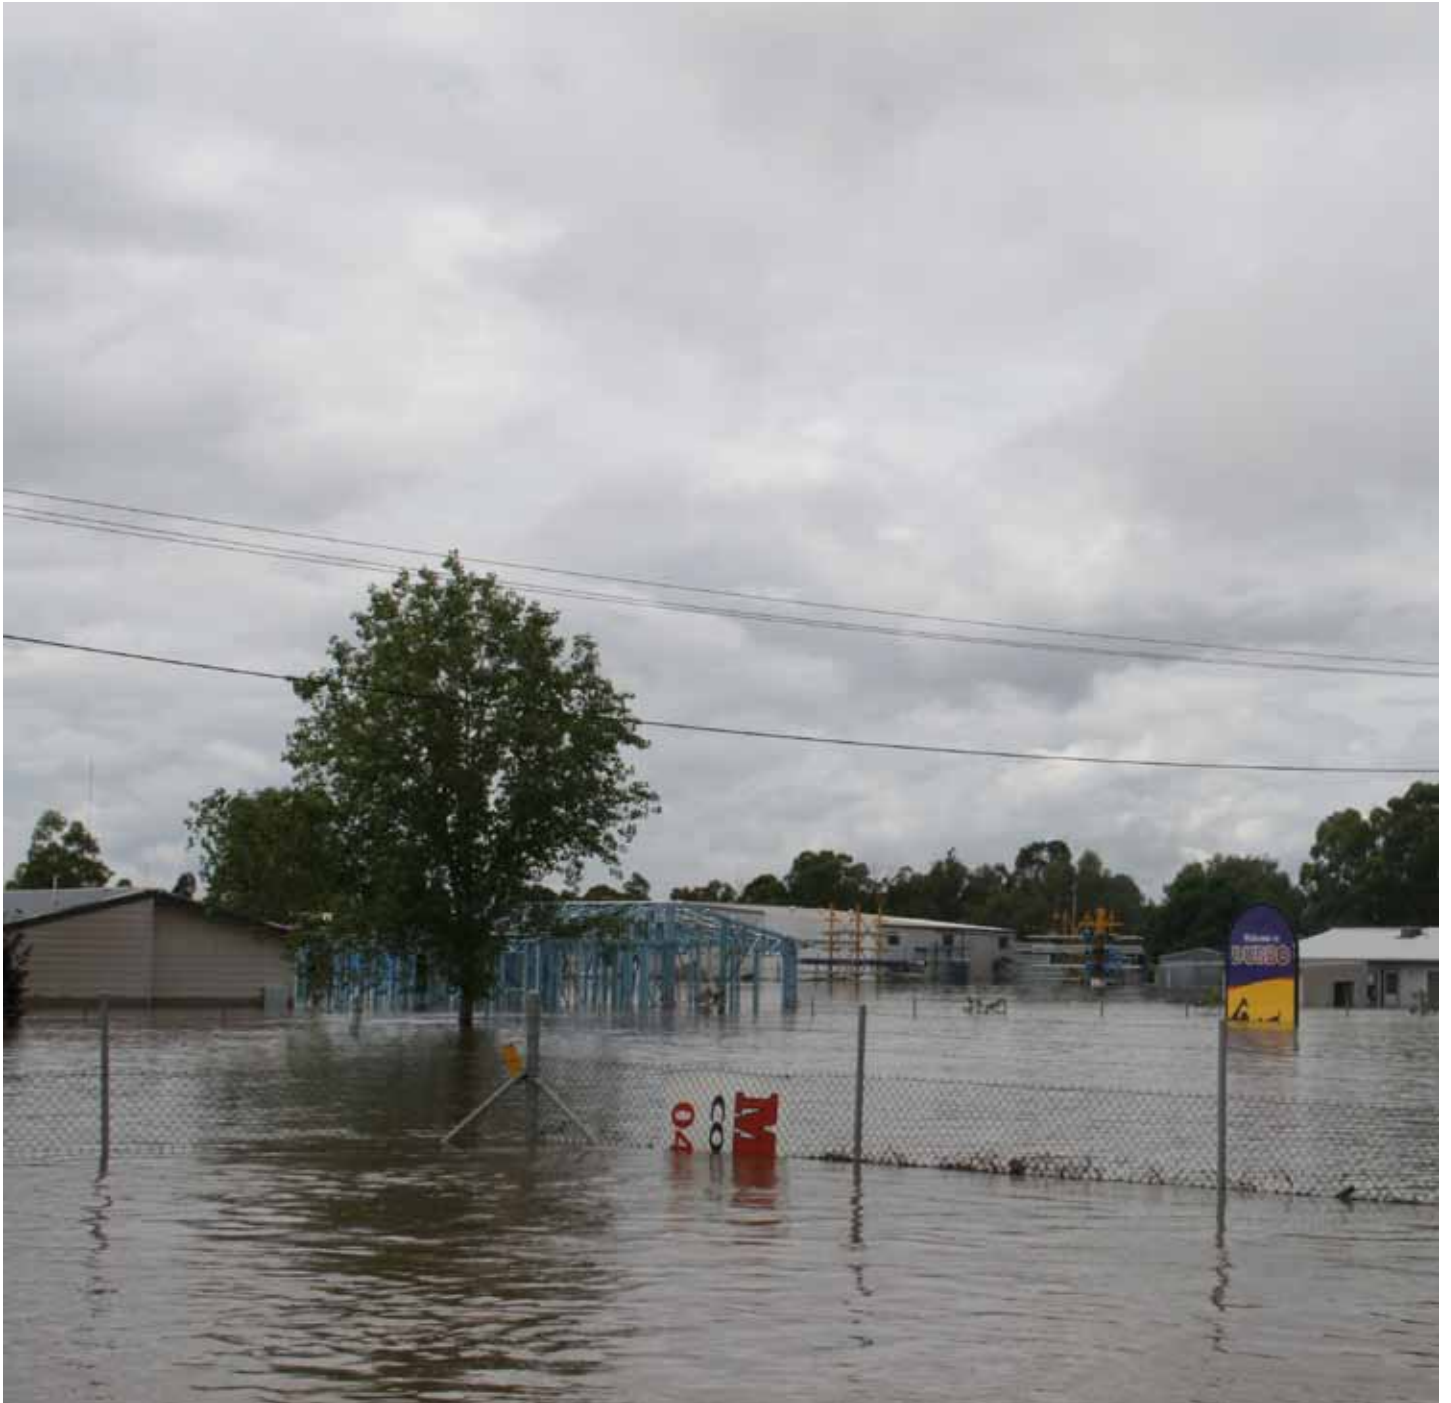
In summary, steel frames have performed well in the floods and proved quick and easy to repair.

Paul has since built earthen pads and reinstalled his existing steel framed display buildings above flood height. Along with landscaping this elevation has also made his displays much more noticeable to highway traffic. His new steel framed office and display building are also on a raised pad and under construction demonstrating his commitment to the Transportable Buildings industry and to his ongoing expansion plans.
