ASSESSING THE BUSHFIRE PERFORMANCE OF LOW-RISE STEEL STRUCTURES USING FULL SCALE BUSHFIRE FLAME FRONT SIMULATION

KB Watson¹, JE Leonard², I Bennetts³, MH Kelly⁴, L Macindoe⁵, and TG Clayton⁶

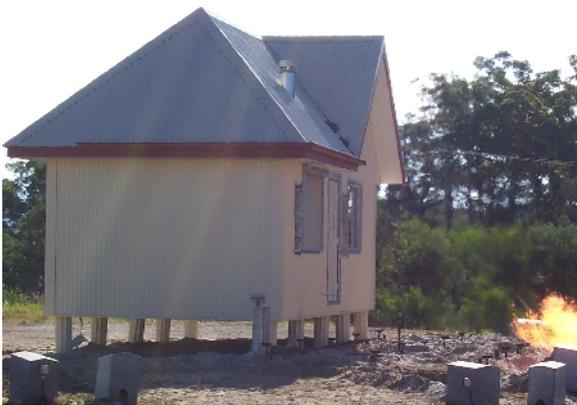
Fig. 2 Pre radiation phase of the testing.

The test building was nominally 8m x 4m x 5m high (see Fig. 2), constructed with steel framing (floor, wall and trussed roof) and suspended on steel stumps such that it was about 0.5 m off the ground. The design incorporated a number of typical building characteristics including a gable and hip roof. Steel sheeting was used for the external cladding including the underside of the floor and the majority of the eaves lining except for two sections which were lined with calcium silicate board for comparison. Two windows (one involving a protective curtain and AS 1530.8.2 rated for flame zone) and a solid core timber door protected by a steel security door were located on the front wall and a sliding glass door (met AS3959 BAL 40 requirements except a screen wasn't installed) on the back wall. The floor, wall and ceiling were insulated with fibreglass batts while foil backed fibreglass insulation blanket was installed under the roof sheeting. 10mm plasterboard was used for the internal wall and ceiling lining. Cement sheeting was used for the floor. Timber skirting and architraves were used around the walls, windows and doors. Various other common components such as a flue, down lights, ceiling access panels, and power switches were included.

- The variation in the air temperature on the outside of the building is shown in Fig. 7.
- The stumps were protected (see Fig 2) from the heat. The data indicate they would have been exposed to excessive temperatures without this protection.

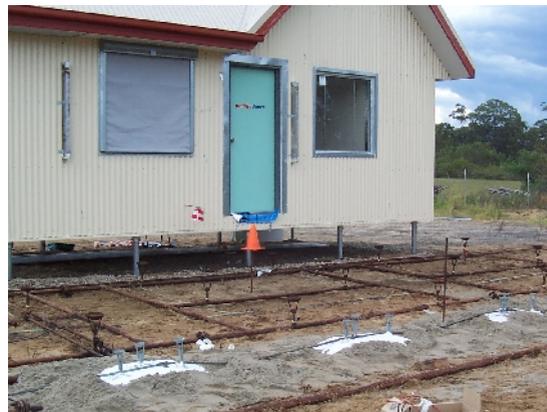
Fig. 3 Liquid propane burners

The grid layout for testing the building is shown in Fig. 3. It consists of a row of 3 burner clusters about 5m from the front of the house which are used for the pre-radiation (see foreground in Fig. 3) and post-radiation phases of the test. The jet size of each burner in the cluster is different and can be activated singularly or in combination to provide a stepwise flame intensity and hence radiation profile on the building. The large 6 x 3 grid of burners adjacent to the front wall of the building (see centre in Fig. 3) can provide a 16 MW/m fire line intensity for the flame immersion phase (see Fig. 4).
