# STRUCTURAL ROBUSTNESS AND FIRE

Ian Bennetts<sup>1</sup> and Lam Pham<sup>2</sup>

**ABSTRACT:** *Structural robustness is a performance requirement in most structural codes and standards. The consideration of fire in relation to robustness has been prompted by reviews of major fires in buildings, some of which were the result of terrorist attack. This paper examines the issue of robustness from a fire perspective by considering some of these incidents and the findings from research on the robustness of framed construction. This paper considers whether buildings can be considered to be robust under fire conditions if they meet the design criteria of BV2 of the National Construction Code 2016 in addition to the requirements of Section C (fire-resistance) of that code. It is concluded that demonstrating that BV2(a) (loss of column or similarly critical member) can be achieved under ambient conditions is sufficient evidence that loss of one such member under fire conditions will not result in disproportionate collapse provided the connection details are chosen to avoid the shearing of bolts and crippling of the webs of supporting columns as a result of compression forces induced by

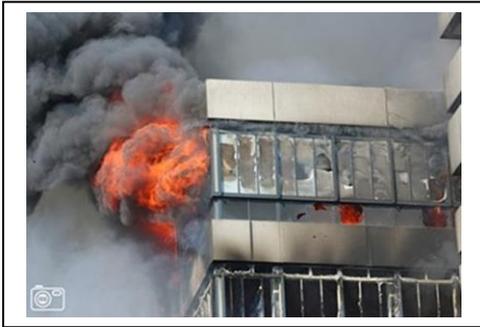
**Figure 2 External burning - Delft University Fire**

Fires in buildings can be localised as with most fires in car parks or in large high spaces such as atria or convention centres or where the combustibles are well separated. In many spaces, if fire growth is unimpeded, the fire will continue to spread and grow reaching a “flashover” conditions where hot gases issue from the openings and a significant proportion of the fuel surfaces are subjected to pyrolysis (the application of heat to the surface to convert the solid surface into combustible gases and particles) or can become fully developed and eventually spread throughout the immediate fire enclosure. During the early stages of a fully-developed fire the rate of pyrolysis can be very high such that only a proportion of the burning takes place within the enclosure but much of it is released externally in the form of flames at the edge of the building (see Figure 2). This has the following potential implications:

- (a) *External* fire spread to the next level. The effectiveness of vertical spandrels (if they exist) at the edge of a building can be limited, particularly if the levels are not compartmentalised (e.g. an open-plan office).
- (b) Columns adjacent to the glazing are heated more significantly than columns in the interior.

- (c) Column stability is reduced if heating is over a double or greater floor height.

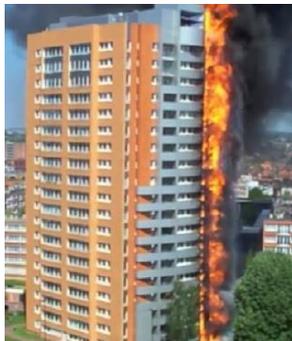
**Figure 3 Vertical Spread Combustible Facade**

A significant related issue associated with multi-storey buildings is the use of combustible facades or curtain walls (Figure 3) which are popular from architectural and energy conservation perspectives but often poorly described (e.g. metal curtain walls with no mention of combustible content) or poorly understood. They are sometimes added without the knowledge of the fire safety engineer being described on the drawings as “metal curtain walls”. The fire shown in Figure 3 is the result of a small fire on balcony at a lower level. Should flaming such as that shown in Figure 2 occur adjacent to such a combustible façade, the fire would be expected to spread rapidly up the height of the building.

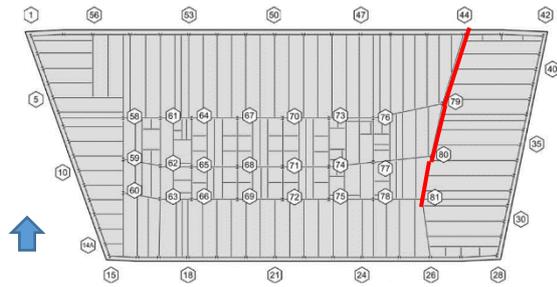
**Figure 4 Typical floor layout for WTC 7**

The steel-framed building incorporated composite floor slabs (W deck) supported by composite beams, which in turn, were supported by non-composite girders. A typical floor plan for levels above Level 7 is shown in Figure 4. Lateral load resistance in both directions was achieved by moment frame action associated with the columns and beams located just inside the building façade. The connections between these members were moment connections. The external column spacing across the North and South faces was 5m whereas that associated with the East and West sides was 2.5m. Exterior belt trusses around the perimeter were also incorporated at two levels. The fires in WTC 7 were due to the collapse of WTC 1 located 105m to the South. Not only was there physical damage to parts of the building, burning materials entered the broken façade and initiated fires on multiple levels (10 floors) however, only the fires on Levels 7–9 and 11-13 lasted until collapse.

The collapse has been attributed to failure of the girders connecting interior columns 79, 80 and 81 (see Figure 4) due to instability of these girders caused by compression due to restraint of thermal expansion exacerbated by one-sided expansion of the attached beams causing twisting of the girders. Ultimately this resulted in failure of the connections with collapse of the floor and loss of restraint to the main interior columns. The failure of these columns initiated progressive collapse of the building.

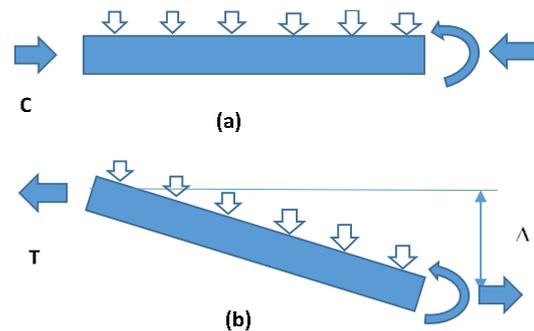
**Figure 5 Actions experienced during fire**

Figure 5 illustrates that as steel beams expand when heated, any restraint of expansion will create compressive forces (see (a)). For example, a rise in temperature of  $200^\circ\text{C}$  for a non-composite girder

of 16m length will result in an expansion of around 40mm.

The associated compressive axial forces can be significant and may result in local or torsional buckling of the girder assuming adequate connection ductility (web or flange permitted to bear directly on column). The effect of buckling, combined with the reduction in strength with temperature is such that the bending resistance can be reduced to the extent, that in order to resist the applied floor loads, a component of the resistance must be provided through catenary action (see (b)) with axial tension forces acting in the beams and through the connections. Unless the connections can resist the combined tension and reaction loads, failure can occur.

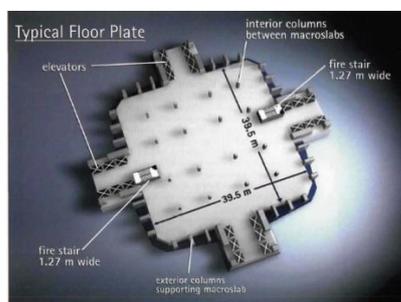
Figure 6 Typical floor plan (after [8])

The building structure has been described as a “concrete super-frame” [9] whereby the building consists of large external reinforced concrete columns with 3m high post-tensioned transfer floors (called macro slabs) every 12 storeys. Each macro slab provided vertical support to a steel-framed 10 storey building which was laterally supported by the reinforced concrete columns. These steel frames consisted of steel columns and beams supporting composite slabs. The details of connections between beams and columns are unknown. A typical floor plan showing the interior steel columns and exterior reinforced concrete columns is shown in Figure 6.

As will be noted from Figure 6, there is no central core. If combustibles were distributed across the entire floor, given the distance to the façade, a fire of long duration (approaching the severity associated with 2 hour standard fire) could have developed on each floor. The increased window area compared to WTC 7 may have reduced the comparative burning duration but, on the other hand, would have also increased the likelihood of external fire spread. Unfortunately, nothing is known about the level of fire load or its distribution across the floor. Post-fire observations indicated that two floor decks had partially collapsed and that several beams were severely deformed. No details are known of the level of fire protection actually applied to the steel but clearly it was sufficient to prevent excessive temperatures in the steelwork.

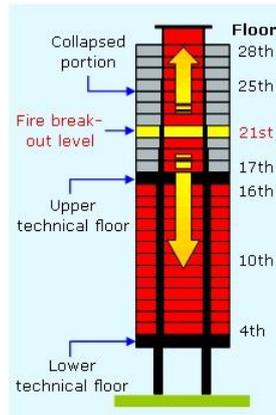
Figure 7 Progression of fire (after [10])

The following discussion is essentially based on the description given in Ref [10]. On February 2005 at 11pm, a fire occurred in the 32 storey Windsor office tower in Madrid, Spain. Given the time of the fire, the building was unoccupied at the time of the fire. It was also the subject of a progressive upgrade program for the fire safety systems which included the protection of steelwork, fire stopping of penetrations and the installation of sprinklers. None of these tasks had been completed at the time of the fire. The building incorporated a concrete core, two reinforced concrete transfer structures (called “technical floors”) and reinforced concrete internal columns. The exterior columns around the perimeter of the façade were unprotected steel members as were internal beams spanning between the reinforced concrete columns. The floors were two-way waffle floors which were vertically supported by the core, the reinforced concrete columns in association with internal unprotected steel beams and the unprotected perimeter columns. The fire commenced on the 21<sup>st</sup> floor but within one hour all of the floors above that level (11 storeys) were involved in the fire. In the following hours, the fire spread downwards due to burning materials dropping through unsealed penetrations. Two hours after the above fire spread, chunks of the façade began to fall off and after another 2 hours (4am) the floor slabs above level 17

collapsed but due to the presence of the technical floor below level 17, no floors below level 17 collapsed. This was also the case despite the continued spread of fire downwards. It needs to be noted that the structural steelwork below level 17 had been substantially protected as part of the upgrade program. The building has had to be replaced.

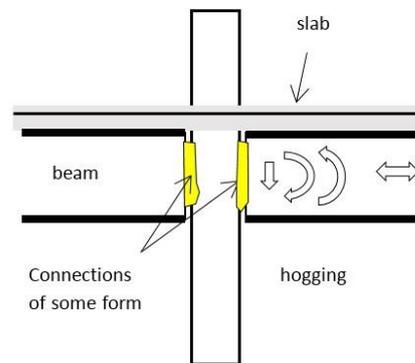
**Figure 8 Typical Connection showing Actions**

References [16] and [18] describe the development of various assessment methods for determining the “robustness” of open-deck carpark structures. Global finite element models (FEM) have been developed to seek to model a range of connections including connections in steel-framed building utilising composite slabs. These models have been “calibrated” against test results for a range of connections. Simplified models have also been developed for use by the practitioner based on a combination of theoretical studies using FEM and test data. For the purpose of the current discussion, a generalised connection is shown in Figure 8.

A type of connection considered in [16] and [18] as being capable of permitting “robust” performance for a steel frame under both ambient and elevated temperature is based on the fitted endplate connection.

This connection is used in conjunction with a composite slab with ductile reinforcing bars in the slab at the connection location to enhance the hogging moment capacity. The potential failure modes with the above connection under fire exposure conditions are (a) failure of a connection component (e.g. bolts) due to tensile forces, (b) failure due to shear force (sometimes called punching shear) and (c) failure of the reinforcement due to excessive strain at a crack.

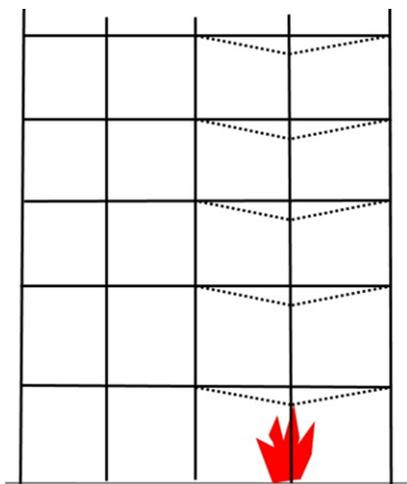
**Figure 9 Local Fire Exposure**

A fire associated with the lowest level is illustrated in Figure 9. Loss of a column at a lower or mid-level results in vertical displacement of all of the floors above with the loads normally resisted by the column now being resisted by the double span beams at the fire level and the levels above. Proportionally more load will be resisted by the ambient floors due to their greater stiffness. The vertical deformation at the column location results in sagging bending at this location and hogging bending at the adjacent columns on each level. The development of tensile membrane forces in the beams can be very beneficial but depends on the ductility of the connections (particularly for the ambient floors) under combined bending and tension and the *ability of the surrounding structure to resist these tensile forces*. The loss of an exterior column and particularly a corner column can present a greater challenge. The magnitude of membrane tensile force *required* to achieve equilibrium is a function of the deflection (or sag)

at the (failed) column location and the sagging and hogging bending capacities. For example, a total in-plane extension of 32mm (e.g. 16mm at each end) of 10m span beams on each side of a column will permit a total sag of 800mm. The ductility of the connections whilst sustaining significant net tension forces is therefore critical and can be achieved under ambient conditions if appropriate connection details are used. Under elevated temperature conditions, the ductility increases whilst the bending and tensile capacity reduce. Nevertheless, application of the above approach can be used to demonstrate that loss of a column in an upper level of the building or at ground level will not result in progressive collapse, despite failure of a column. This is true under both ambient and fire conditions provided suitable connections are used.
